Avian Collisions at the Columbia Building

Avian Collisions at the Columbia Building: A synthesis of pre- and post-retrofit monitoring

September 9, 2020

Report prepared by
City of Portland Bureau of Environmental Services, Portland, Oregon
and Portland Audubon

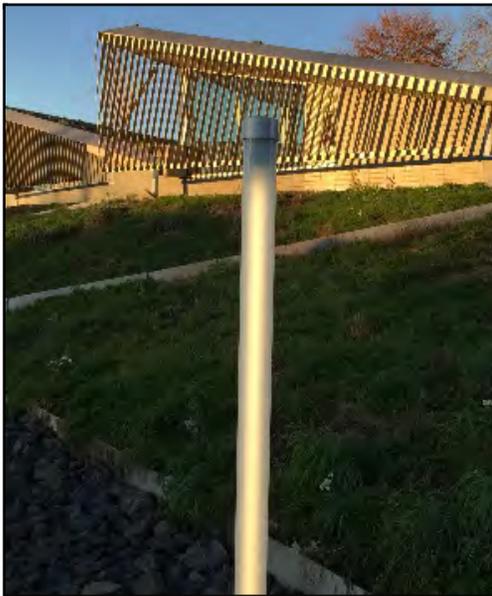
Photo 1: Example of unshielded tube light at the Columbia Building.

Though the relationship between lighting and window collisions has not been studied at this building, unshielded lighting may be a factor contributing locally to the window collision hazard. Adherence to best practices in lighting design can minimize light pollution and its unintended consequences, which are further addressed in Appendix F and in the separate memorandum: *Recommendations to Address Bird Window Collisions at the Columbia Building*.

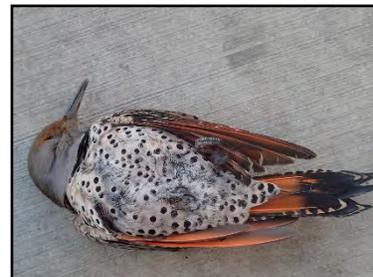
Photo 2: Northern Flicker window collision at Columbia Building

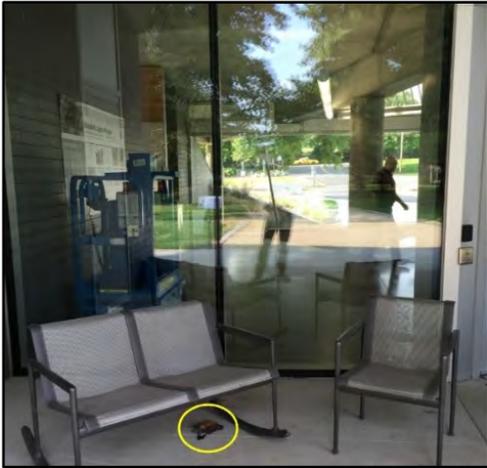
Photo 3: Example of the fly through hazard created by the lobby windows. A car is visible on Columbia Blvd on the other side of the building. A window collision robin carcass lies under the bench.

The second hazard is a fly-through illusion. The north and south lobby windows together create the illusion of a clear flight pathway through the lobby to the opposite side of the building. Fly-through hazards are also present on the NE and NW corners of the building where there are proximate panes of glass on adjacent surfaces. Although not flagged as high risk during the initial risk assessment, phase two surveys revealed that there may

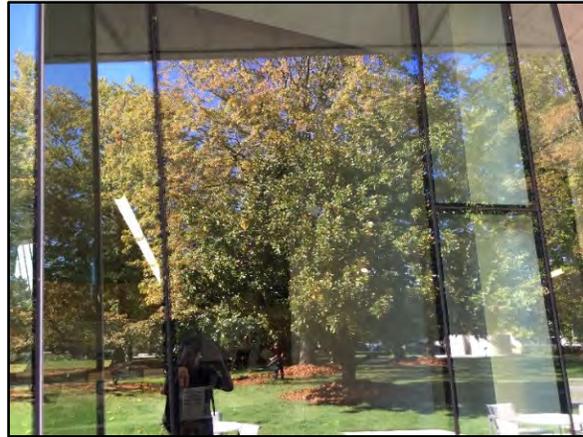
Photo 4: Example of the reflection hazard created by north facing windows adjacent to vegetated campus setting.

Two distinct window collision hazards are present for birds at the Columbia Building: reflectivity and transparency. The primary hazard results from reflections created by large contiguous glass surfaces on the north face of the building. These highly reflective windows reflect sky as well as numerous trees and shrubs in the landscaping on the north side of the building. Birds perceive the glass surfaces as a continuation of the vegetated landscape and as open sky. This hazard is present under all observed daylight conditions and may be worse in brighter conditions (we believe the majority of bird collisions occur on this building during daylight hours).

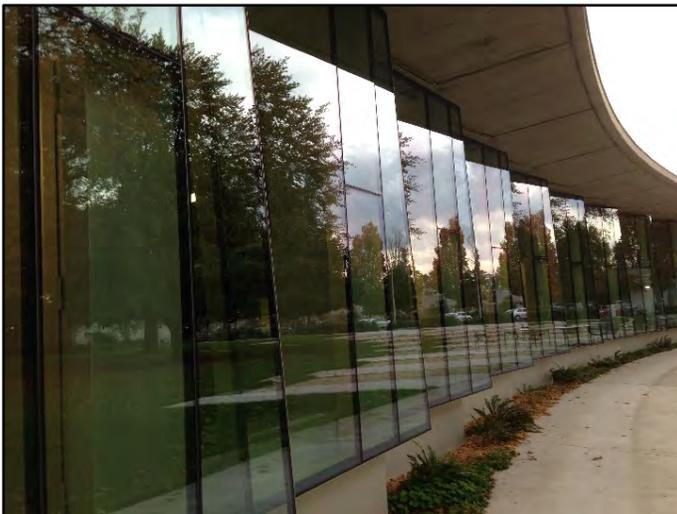
Photo 5: Another example of deceptive reflections creating a collision hazard on north-facing window banks.

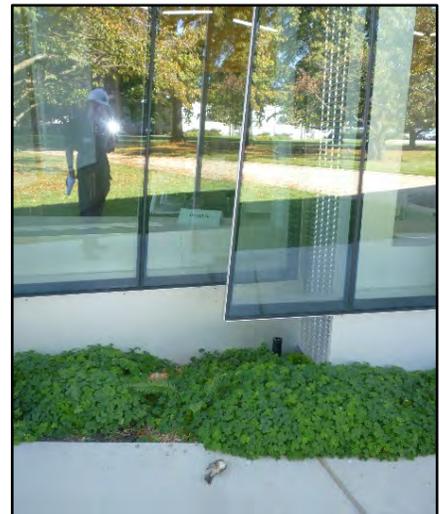
Photo 6: White-crowned sparrow window collision at north windows, Columbia Building (carcass in foreground on sidewalk).

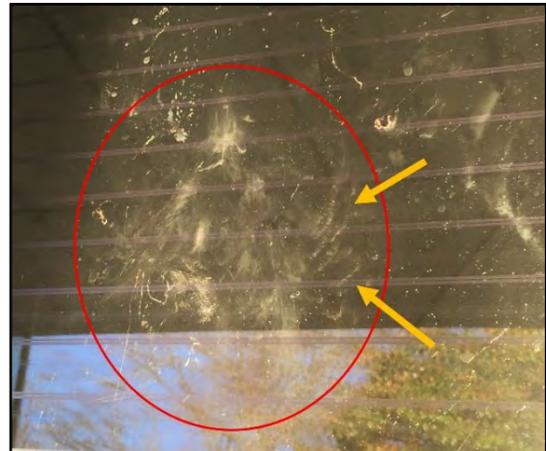
Photos 7 and 8: Examples of feathers remaining on a window from a bird collision (left) and a print from a bird collision incident (right) from the Columbia Building. The print is one of six collisions found after the window film was installed. Arrows point to a clear feather pattern: feathers from the right wing of a medium sized bird that collided with the window. See Appendix C for print and feather photographs from the Columbia Building.

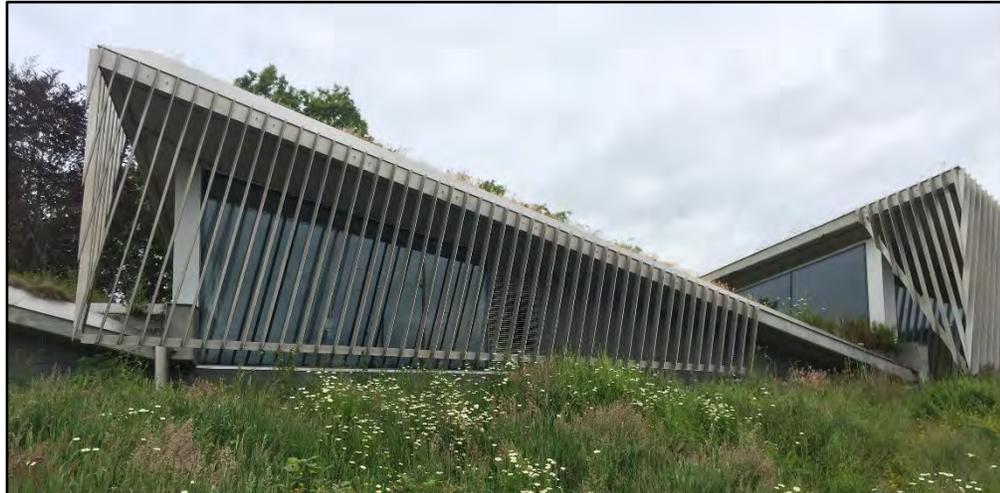
Photo 9: South facing window behind louvers. The triangular window on the right without louvers is one of the clerestory windows that faces the ecoroofs.

Additionally, four collisions were detected on untreated south and east-facing kitchen windows, which are associated with louvers, adjacent to a large opening in the roof overhang (see yellow symbols in Appendix A.3). This opening creates a unique fly-through opportunity relative to other louvered areas along the south side. These four detections on untreated windows behind louvers indicate that louvers alone are not sufficient to deter collisions when associated with an open roofline approach to the glass. We did not detect collisions at the four other south facing windows with louvers (labeled S. Face 1, 2, 3 and 4 in Appendix A.1). This supports the hypothesis that louvers help to deter collisions and indicates that the fly-through opportunity created by the unique configuration of these south and east-facing kitchen windows at the southeast corner of the building is the main variable in these four collisions.

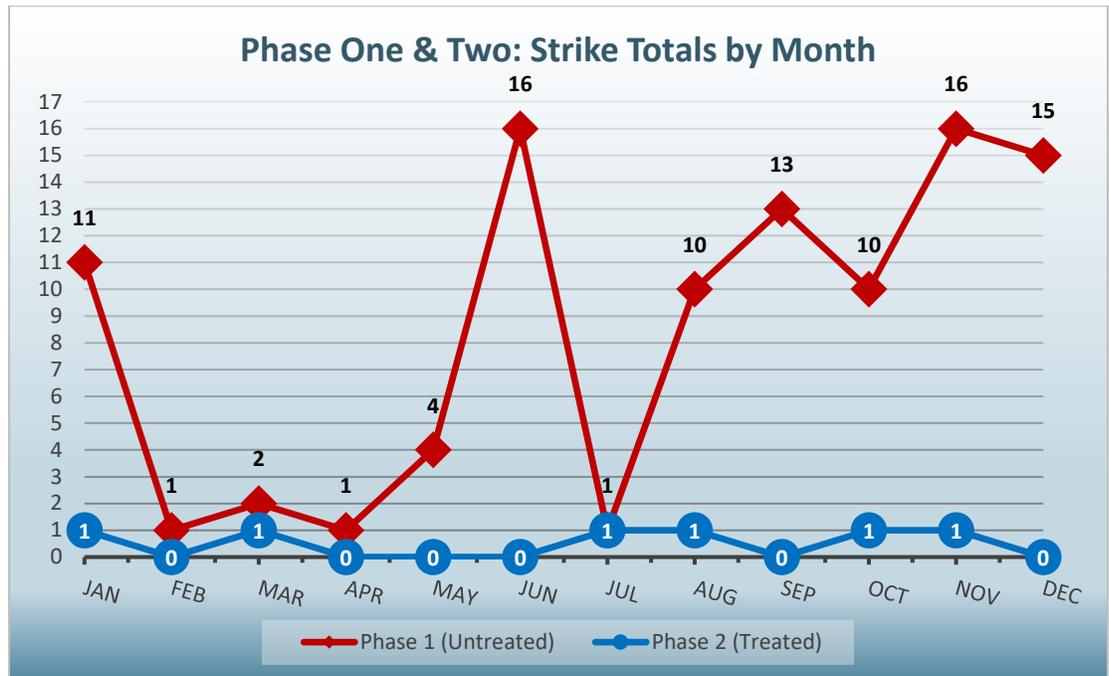
Figure 5: Phase one (pre-treatment) and phase two (post-treatment) collision detection totals by month.

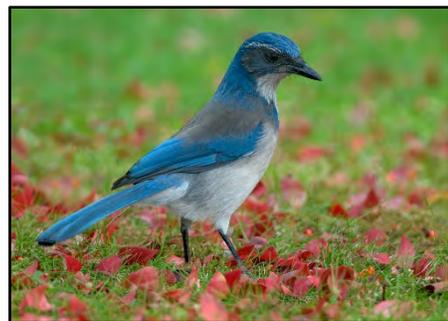
Photo 11: California scrub-jay was the only species positively identified among the four phase two collisions on treated windows.

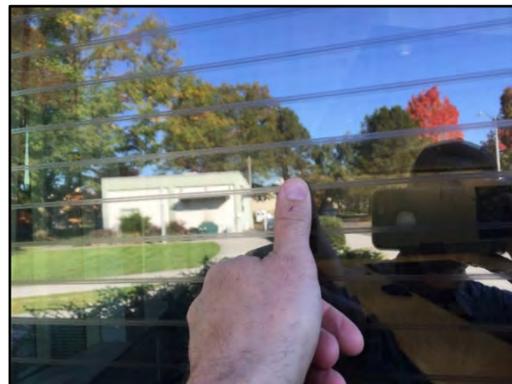
The BSFH product from Solyx is a durable, fully transparent, scratch-resistant polyester film featuring a horizontal stripe pattern with one-inch spacing. The durability and scratch resistance conformed to needs of BES for a minimal maintenance product. The horizontal stripe pattern option was chosen, as opposed to the other available designs such as vertical stripe, trellis/cross and dots, because it was a good aesthetic fit for the building and appeared to provide minimal visual disruption for building occupants. The Solyx film was installed by a professional installer on 35 windowpanes totaling 3,424 square feet of widow surface. This retrofit was completed in October 2017 at a total cost of \$28,544 (\$8.34 per square foot).

Photo 11: Close up of Solyx window film

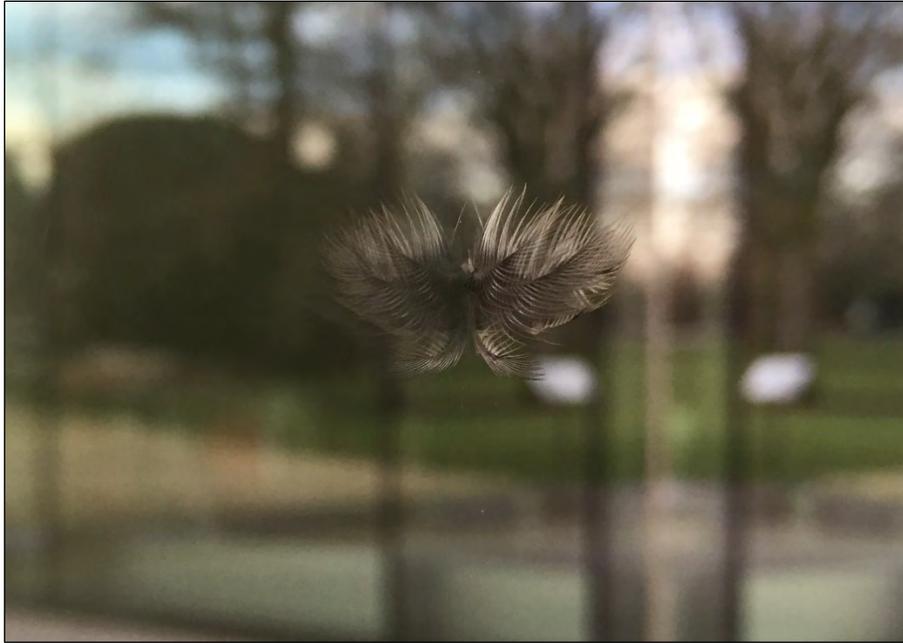
Example of feather evidence of a bird window strike at the Columbia Building north lobby windows. This feather is about 1 cm wide.

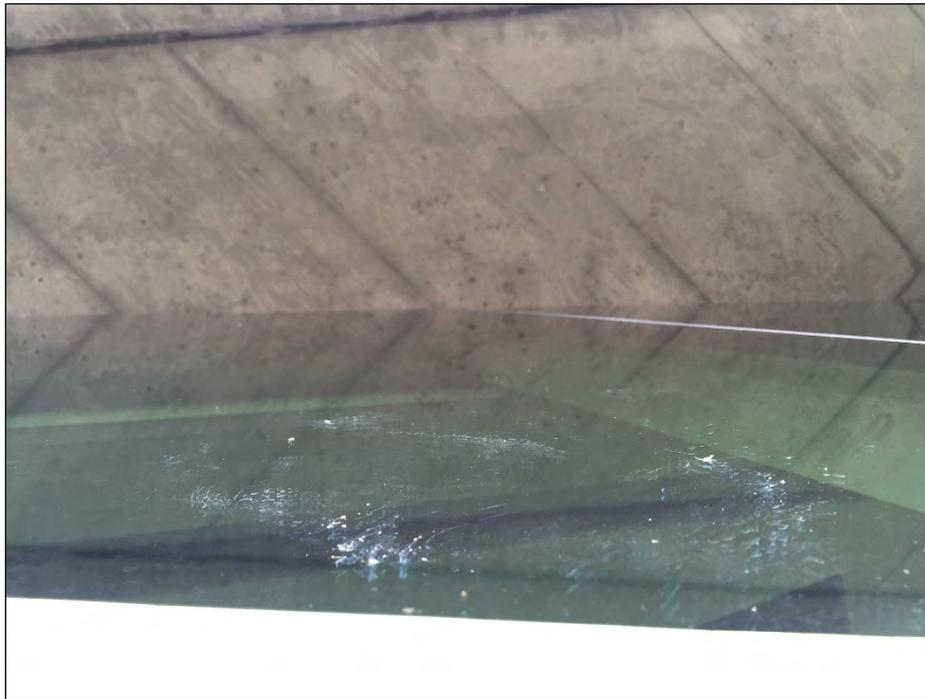
Example of print evidence of a bird window strike at the Columbia Building Mazama conference room windows.
